HOW DOES COASTAL MANAGEMENT IMPACT CLIFF RECESSION IN THE SWANAGE BAY?

How do Coastal Management Strategies affect Cliff recession in the Swanage Bay?

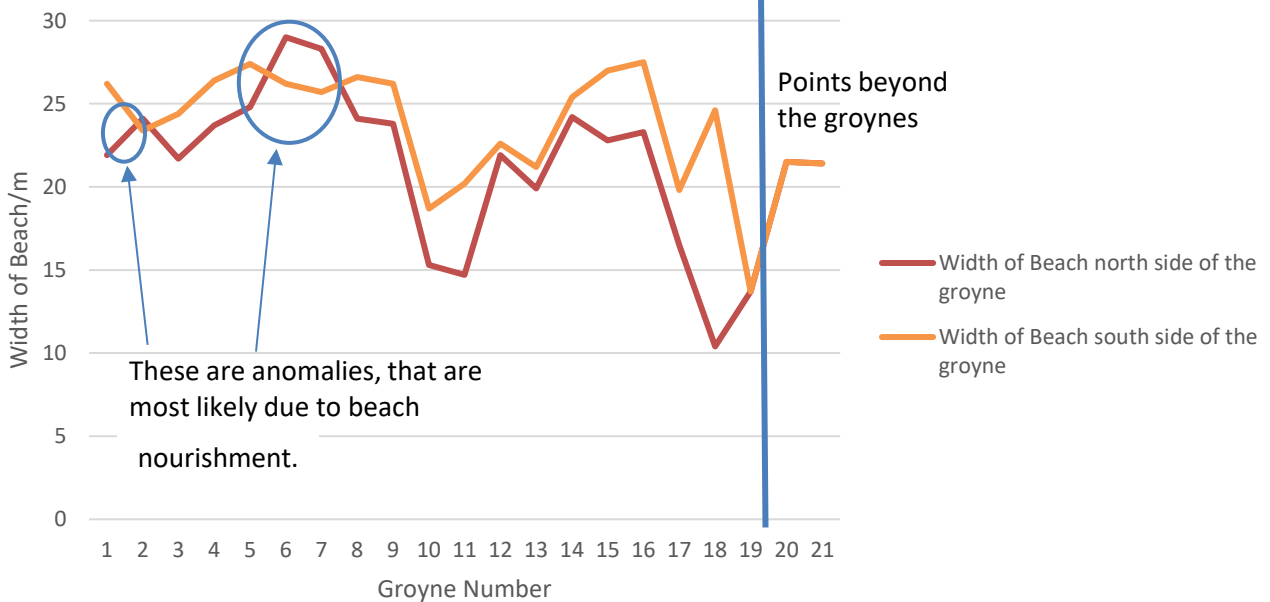
Fig 13

This is a line graph comparing the widths of the beach on both sides at each groyne

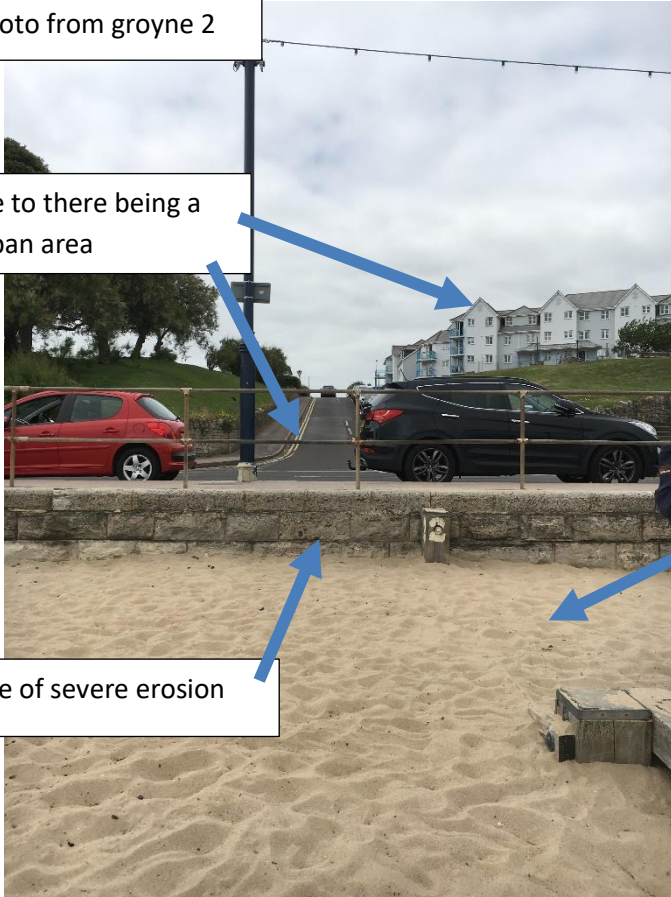
Fig 20 – This is a photo from groyne 2

There is no road due to there being a road and a more urban area

The groyne has been so effective that there is no change in height at the top of the groyne

No evidence of severe erosion

We can also see how the cliffs have changed in my photo analysis, with there being no cliffs or erosion present in the early groynes as shown in fig 20, however with the more northern groynes, there are some substantial changes, especially around groyne 7 (fig 22) with there being no erosion at the bottom of the cliff due to a small sea wall but slumping at the top of the cliff. This indicates that although there is the threat from the sea, the weather can be much more destructive. This is due to the amount of rainfall the area has had in past and as a result it would have weakened the soil and caused the cliff to slump. In fig 24, we can see how the Pines Hotel owner has implemented cliff defences to stop this from happening.

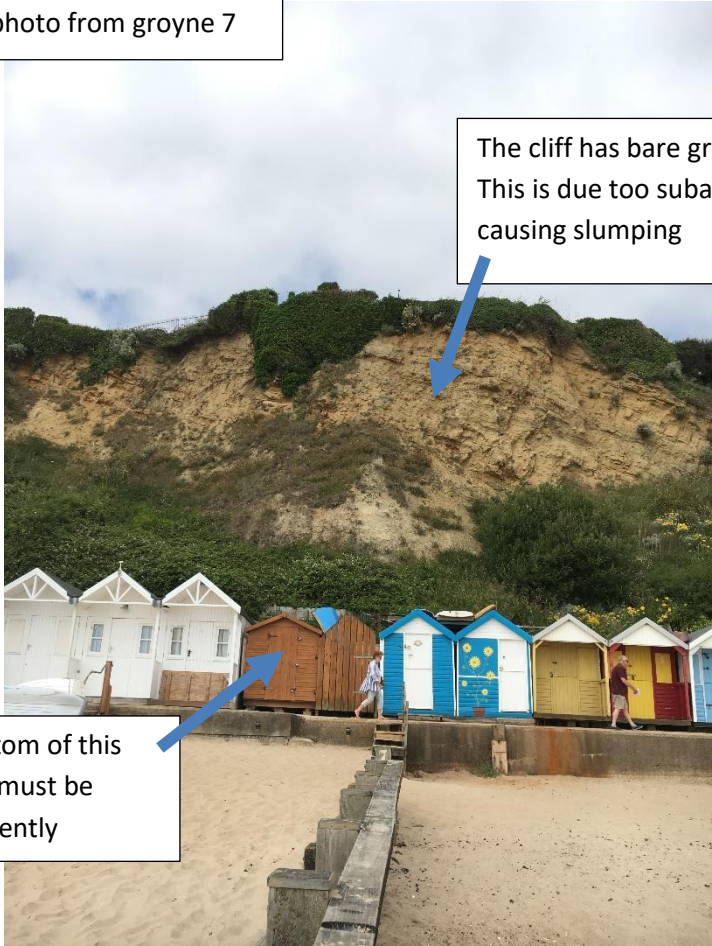
Fig 22 – This is a photo from groyne 7

The cliff has bare ground showing here. This is due to subaerial processes, causing slumping

Beach Huts are at the bottom of this cliff, the coastal defences must be protecting this area sufficiently

The main subaerial process that effects the Wealdon stone cliffs is the weather as when the ground becomes too saturated with rainwater, it slumps and causes rotational slip. This can be seen clearly in figures 22, 23 and 26 with them being an example of recent slumping. In fig 24, the hotel owner has even put a drainage built into their sea wall to help get rid of the water. The plants have a different effect on the Wealdon stone and the Greensand than on the limestone, with adding more support to the cliffs through their roots.

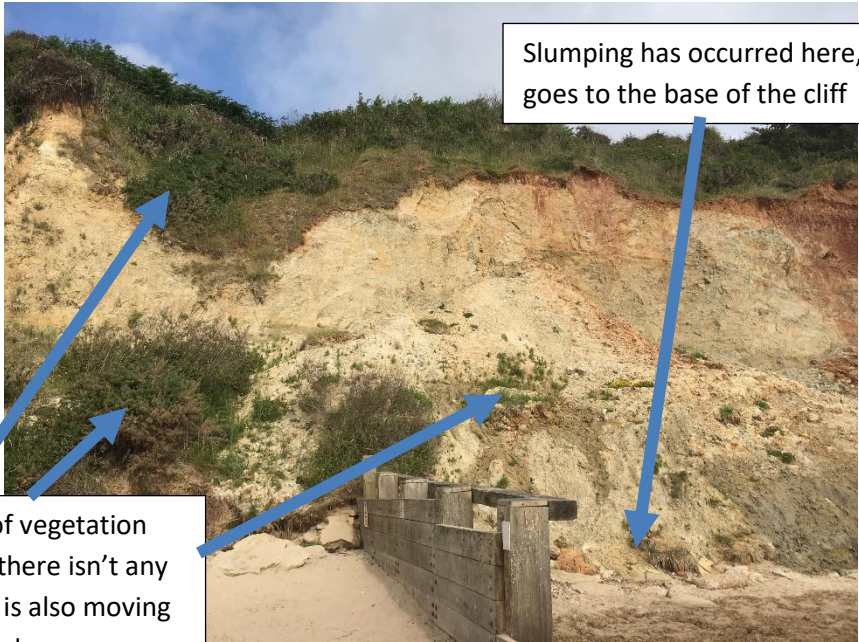
Fig 23 – This is a photo from groyne 18 of the cliff

Slumping has occurred here, and it goes to the base of the cliff

There are some patches of vegetation here and where they are there isn't any slumping. The vegetation is also moving to areas that have slumped.

This differs even further north in the bay at groyne 18 (fig 23). Here we can see how the cliff is being eroded from the base by the sea. The material of this part of the cliff is also the same as the material seen in fig 22, and this shows us that as well as the sea eroding the cliff, the weather is also inflicting damage. Even though there is a groyne here, the cliff is still being eroded – this is because there is no sea wall protecting the cliff base here. The groyne here is in place to secure protection for Swanage. From the photo analysis, we can also see what the cliffs are like beyond the groynes, and this can be seen in figures 25-28. In figure 25, the cliff is clearly getting undercut by the sea (something that is not present further south in the bay), as well as there being large cracks at the base. This shows us that the cliff is more vulnerable here. There was also much more slumping further north in the bay (fig 26) with the cliffs becoming more and more at risk from the sea.

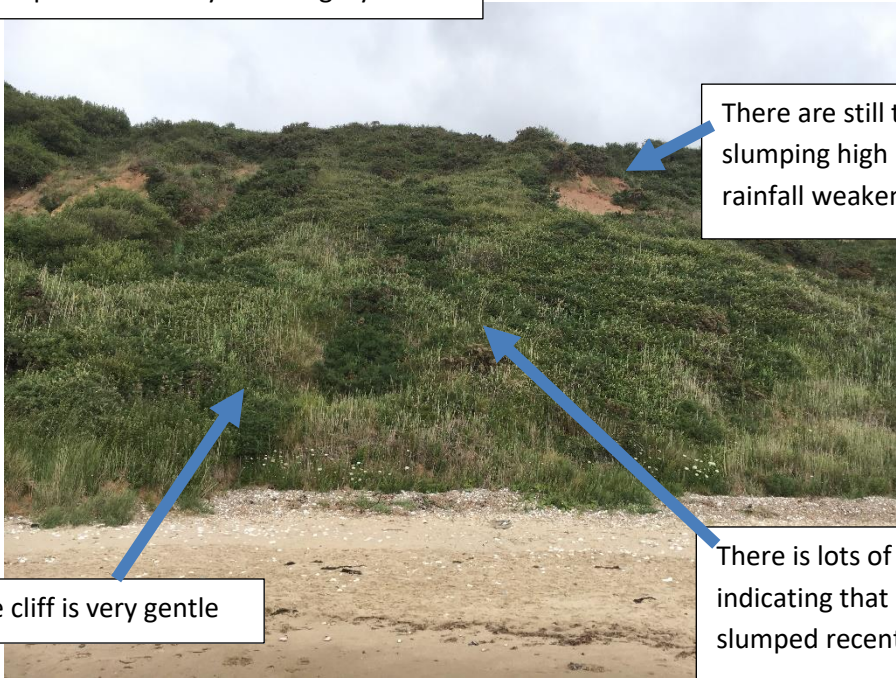
Fig 27 – This is a photo from beyond the groynes

There are still the odd patches of slumping high up, the cliff. This is due to rainfall weakening the cliffs

The slope of the cliff is very gentle

There is lots of vegetation here indicating that it hasn't slumped recently

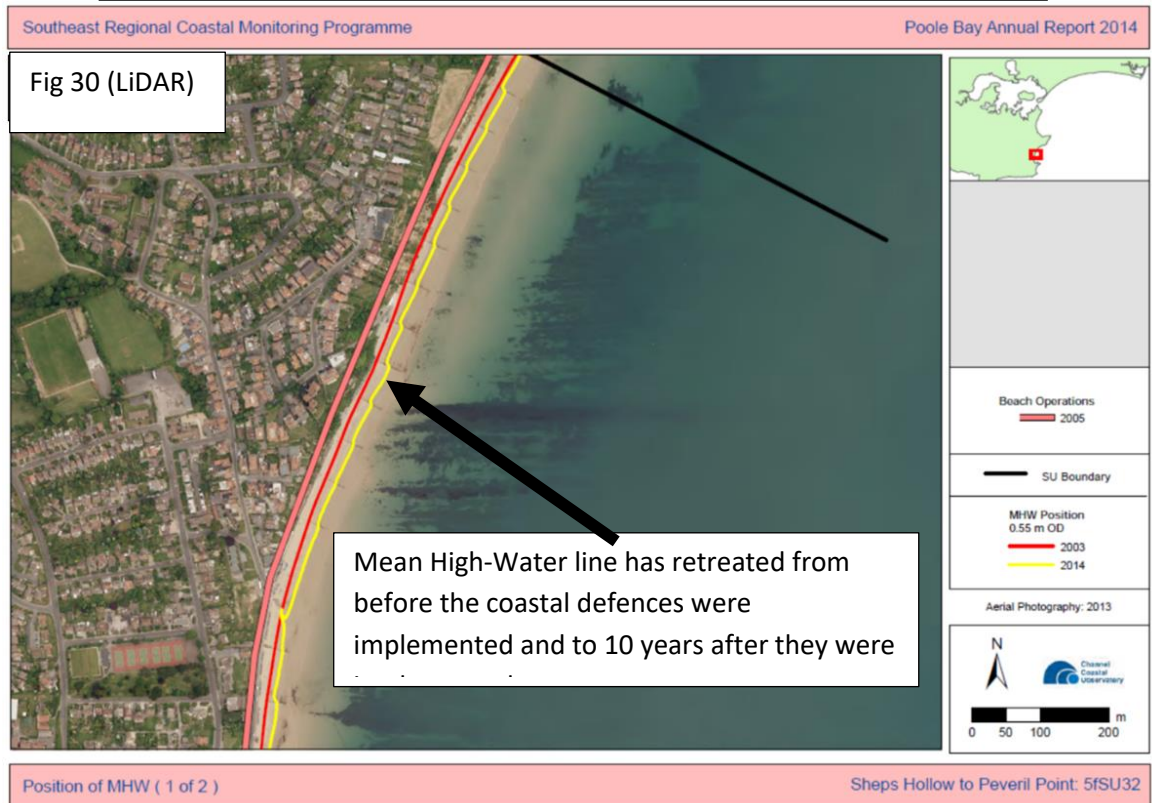
This shows the change in the Mean High-Water line in 2003 and 2014

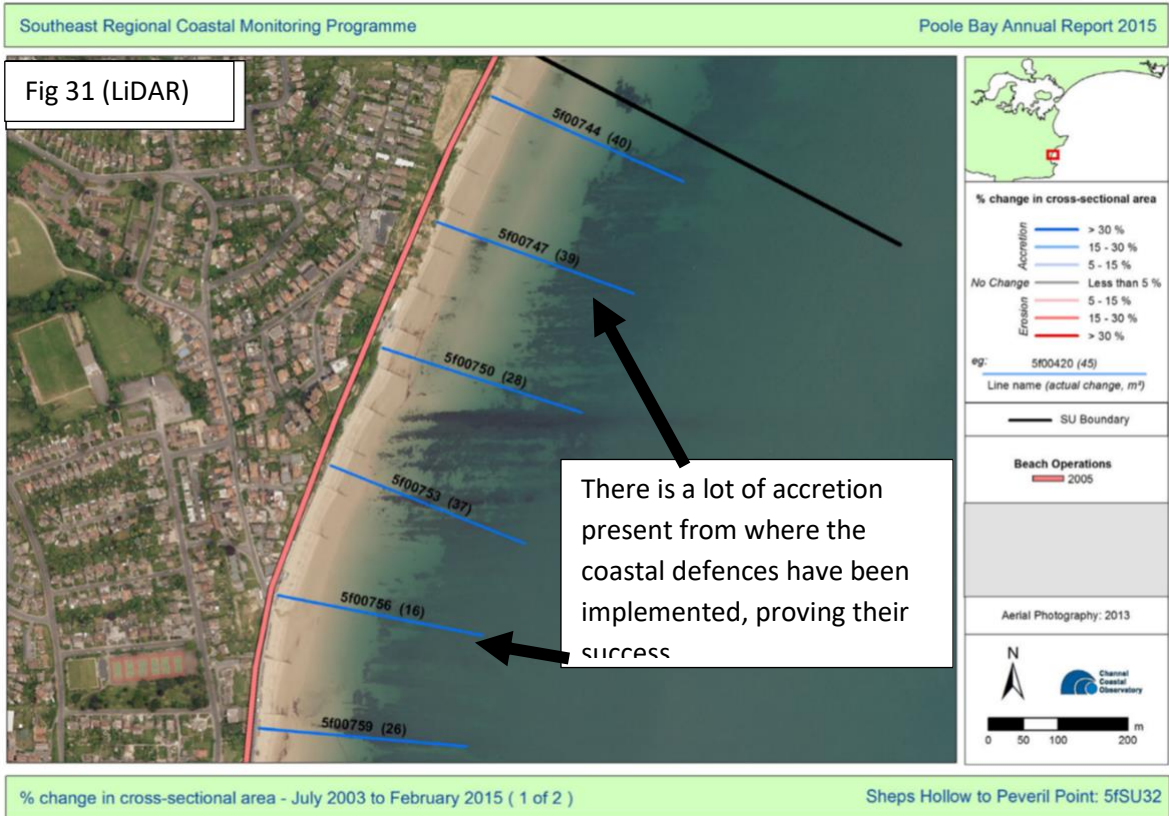
This shows the percentage change in cross-sectional area (2003 – 2015)
